Manhole Inspection Summary

Manhole # S39C2_004MH

Insp Date: **4/25/08 9:55 AM**

Location Address: **4032 6th St.**

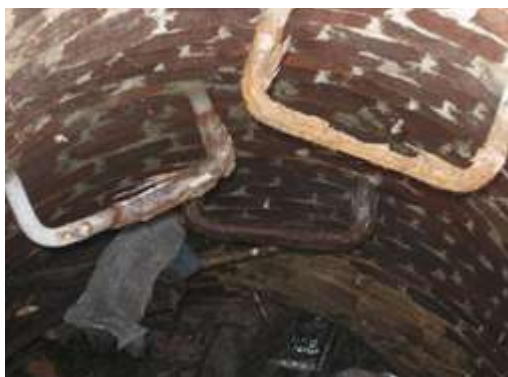
Steps

Count: **4** Missing: **0** ☒ **Corroded**

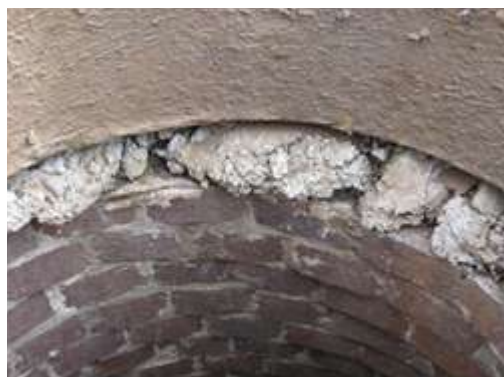
Defect 1

Condition: ☐ Sound ☒ **Cracked** ☐ Root Intrusion ☐ Loose Brick ☐ Deteriorated

Infiltration: ☐ None ☒ **Joint** ☐ Cracks ☐ Mortar ☐ Roots ☐ Wall

Frame Chimney Joint (Cracked)

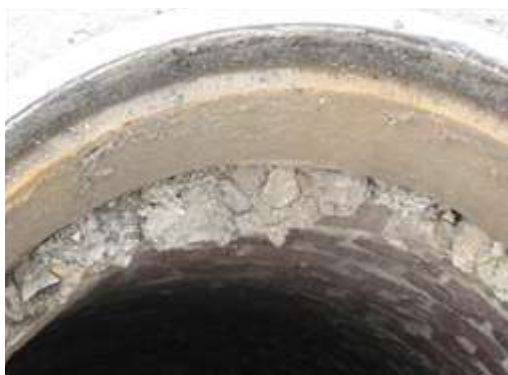
Defect 2

Offset: **2** (in.)

Frame offset

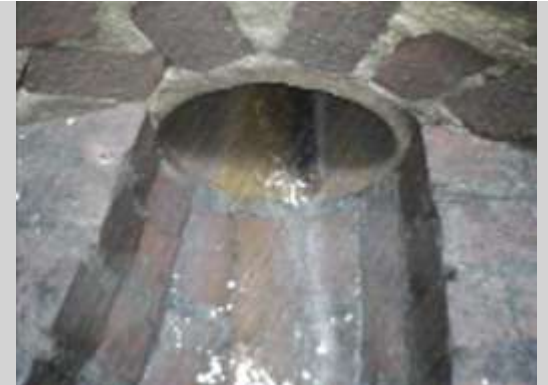
12 O'Clock Outflow

Pipe Height: **8.4** (in.) Rod and Bar (Angled)
Pipe Material: **Clay** ☐ Pipe Lined
Invert Depth: **9.48** (ft.) Flow Characteristics: **Fast**
Deposits: ☒ None ☐ Mud ☐ Sludge ☐ Debris ☐ Grease
Silt Depth: (in.) Deposits Extent:
Infiltration: **None** Pipe Seal Cond: **Sound**

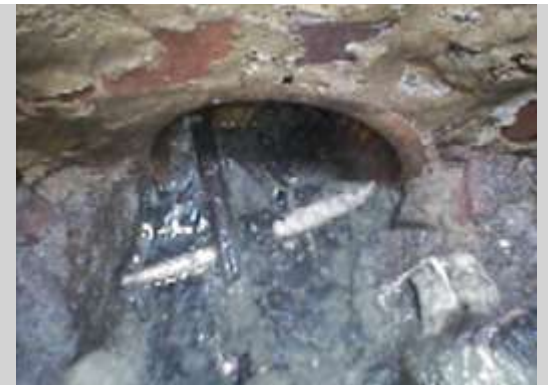
4 O'Clock Inflow

Comments **Unable to accurately measure influent pipe @ 4 O'Clock due to excessive debris and sludge.**

Pipe Height: **3.6** (in.) Rod and Bar (Angled)
Pipe Material: **Clay** ☐ Pipe Lined
Invert Depth: (ft.) Flow Characteristics: **Slow**
Deposits: ☐ None ☐ Mud ☒ Sludge ☒ Debris ☐ Grease
Silt Depth: **4** (in.) Deposits Extent: **Medium**
Infiltration: **None** Pipe Seal Cond: **Sound**

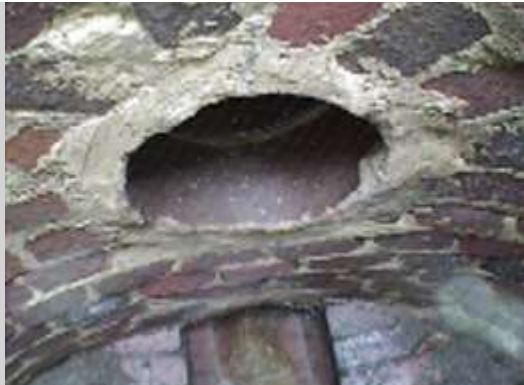
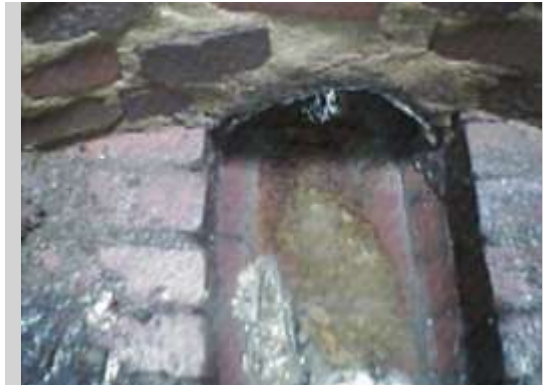
6 O'Clock Inflow

Pipe Height: **8.4** (in.) Rod and Bar (Angled)

Drop: **Outside** Rod and Bar
Angled: **Yes** Reading: **8.08** (ft.)
Inv Depth: **9.08** (ft.)
Drop Condition: **Open**

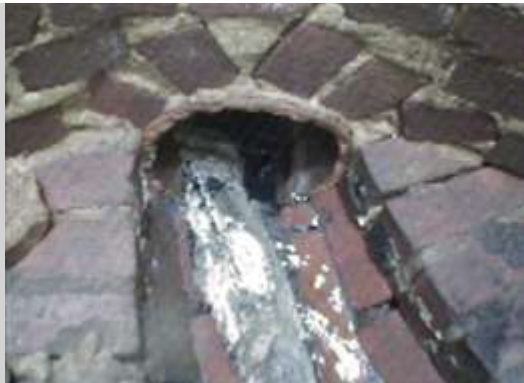
9 O'Clock Inflow

Pipe Height: **8.4** (in.) Rod and Bar (Angled)
